November 26, 2002

Source Removal Report, Tank Site 365

Naval Station Mayport Mayport, Florida

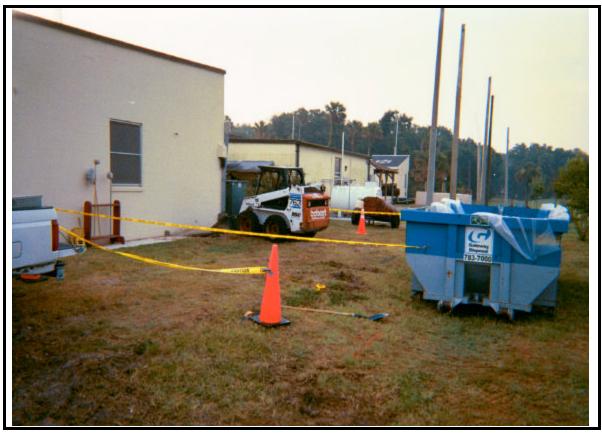
Photograph 1. June 3, 2002. Photograph of Building 365 Site before Excavation activities began.

In preparation for excavation, caution tape was set up around the site. Also, exclusion, contamination, and support or safety zones were established in the area. A health and safety meeting was held and the area assessed by field personnel. All aboveground and underground utilities and other man made structures were noted prior to excavation. A photograph of the site prior to excavation is included as Photograph 1 in Attachment C.

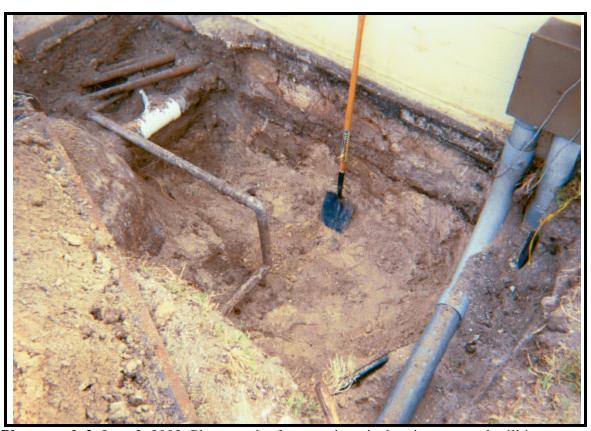
During excavation activities, several underground structures were discovered. Among these discoveries were two telephone lines, a sewer manhole with incoming sewer lines, a conduit containing electrical lines, and one electrical line with no conduit surrounding it. There was a slight petroleum odor detected in the soil excavated until a depth of 3 ft was reached. The soil was a fine to very fine, grained sand fill to 3.5 ft. Native soil was encountered below 3.5 ft and was light brown in color.

The final area of excavation was rectangular in shape measuring 10 ft from north to south and 6.5 ft from east to west. The maximum depth of the excavation was 4 ft. The entire removal effort generated a total of approximately 10 yd<sup>3</sup> of contaminated soil for disposal offsite. Photograph 2 in Attachment C shows the excavation area after all of the soil was removed. The pipes, conduits, and partial sewer manhole are exposed.

**Photograph 2.** June 3, 2002. Photograph of excavation pit showing exposed utilities

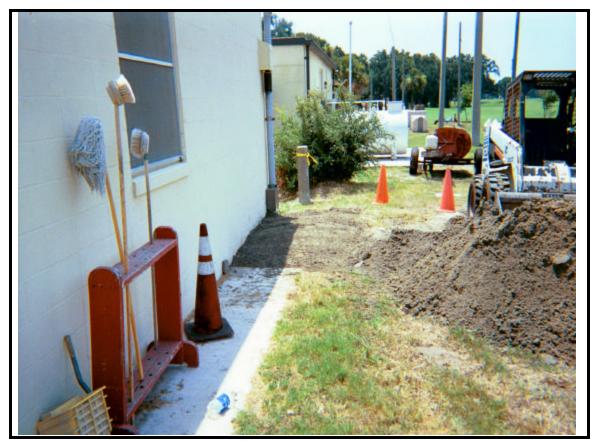
Photograph 3. June 3, 2002. Photo of excavation pit following backfilling.

After determination that impacted soils exceeding FDEP SCTL values had been removed, backfill material was brought on site to be used to fill the excavated area. The material used to backfill the excavation was clean and uncontaminated as certified by Dynamic Land Development. The soil was then compacted to prevent settling of the structures surrounding the site. The soil was compacted using a plate compactor, and the area was leveled and prepared for reseeding. Following the removal of the contaminated material, backfilling, and compaction of backfilled material, the area was re-seeded using a purchased seed mix consisting of Bahia grass and Rye. The re-seeded area was then sufficiently watered to allow for vegetation re-growth. Attachment C contains photographs of the site after the excavation had been backfilled with clean fill. Photographs 3, 4, and 5 show various views of the site after being regraded.

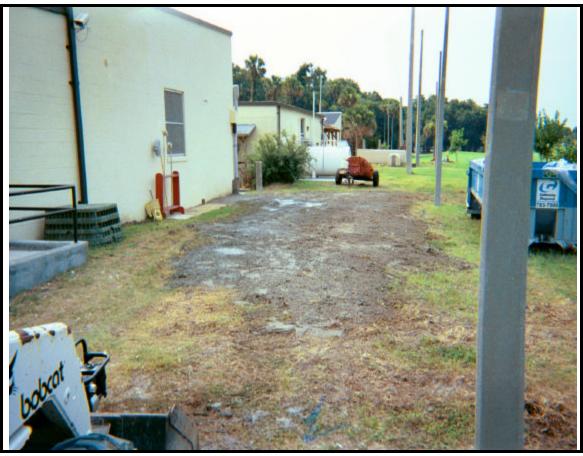
**Photograph 4.** June 3, 2002. Photograph of excavation site following waste disposal, backfilling, and regrading. (View 1)

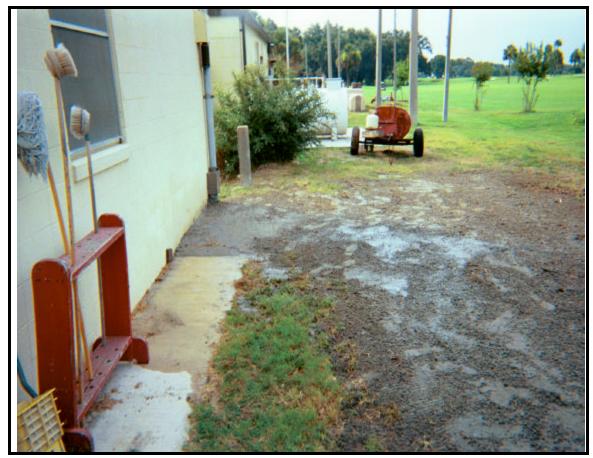
**Photograph 5.** June 3, 2002 . Photograph of excavation site following waste disposal, backfilling, and regrading. (View 2)
